US Army Corps
of Engineers
Waterways Experiment
Station

Zebra Mussel Research Technical Notes

Technical Note ZMR-2-19

Comparison of the Component-Level Performance of Anti-Zebra Mussel Coating Systems with Research Coupon Results

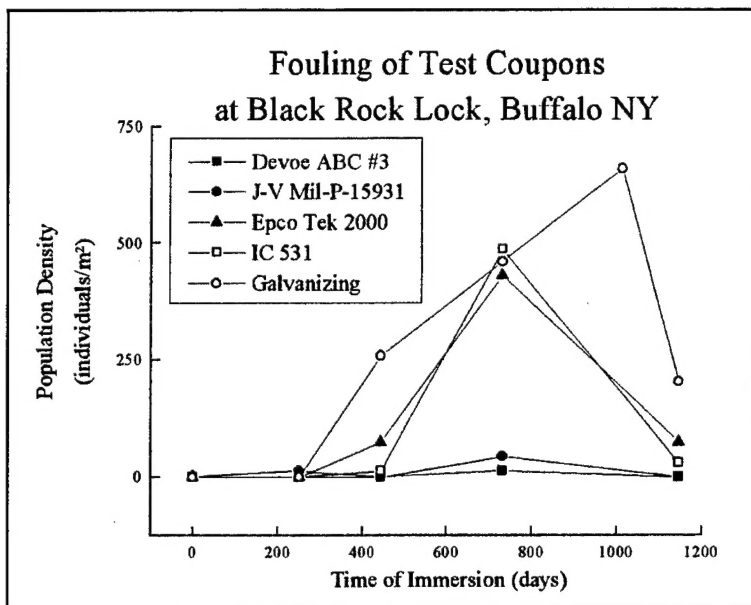
Figure 1 plots the population densities (zebra mussels per square meter) that have infested the test coupons at Black Rock Lock over time. The two copper oxide-containing coatings (Devoe ABC No. 3 and J-V Mil-P-15931) had essentially no zebra mussels during the 3-year test. Infestations on the other coatings seem to have peaked, and are now retreating.

Figure 1. Population density of zebra mussels over time during immersion at Black Rock Lock for copper- and zinc-bearing coatings

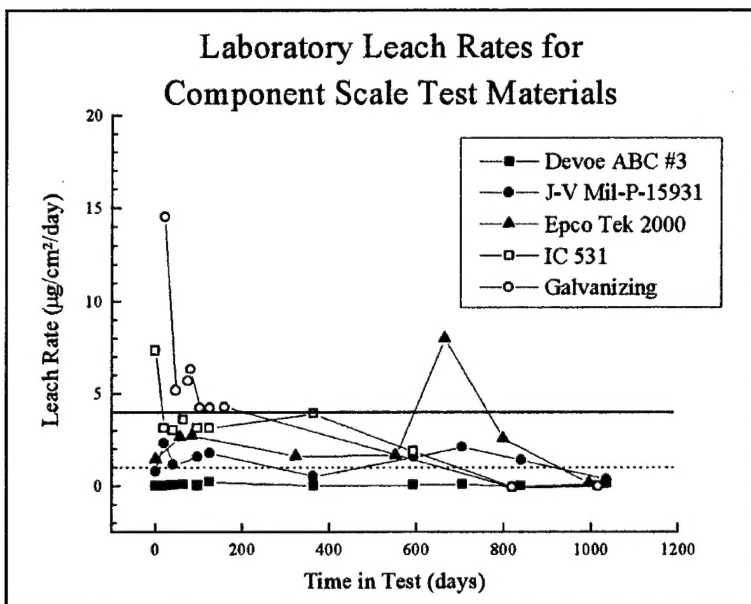
The leach rates of the primary antifouling metal ion, as a function of the time of immersion in flowing water, for the five laboratory-tested coatings are shown in Figure 2. The minimum values of the leach rate estimated for maintaining the antifouling properties in copper- and zinc-bearing coatings are also plotted.

Figure 2. Leach rates of metal ion from copper- and zinc-bearing coatings, measured at intervals over a 3-year period. Horizontal lines indicate the estimated minimum values of leach rate for maintenance of antifouling properties in coatings (dashed line = copper; solid line = zinc-bearing coating)

As laboratory zinc leach rates have fallen, the infestation density has risen at Black Rock Lock. The bars on the trash racks at Markland Lock and Dam have not been coated long enough for the leach rates to have diminished significantly. It is anticipated that the use of thermal-sprayed zinc or zinc alloy materials would work similarly to the inorganic zinc material. These materials might be more abrasion resistant, adhere better, and provide better corrosion inhibition for a longer period.
